Work Order ID 138028

Item ID: D206-667-147TRN Accept ***N900040100*** Setup Start ***NS1***
 Revision ID: Stop ***NS2***
 Item Name: Crosstube Assembly, Mid Fwd
 Start Date: 10/20/2015 Start Qty: 1.00 ***1*** Cust Item ID:
 Required Date: 11/3/2015 Req'd Qty: 1.00 ***1*** Customer:
 Reference:

DART AEROSPACE LTD HAWKESBURY, ONTARIO, CANADA	
DRAWING NO. D206-667-147	REV. A SHEET 1 OF 4
TITLE CROSSTUBE ASS'Y (206L MID FWD)	SCALE NTS
COPYRIGHT © 2010 BY DART AEROSPACE LTD THIS DOCUMENT IS PRIVATE AND CONFIDENTIAL AND IS SUPPLIED ON THE EXPRESS CONDITION THAT IT IS NOT TO BE USED FOR ANY PURPOSES OR COPIED OR REPRODUCED IN ANY MANNER WITHOUT WRITTEN PERMISSION FROM DART AEROSPACE LTD.

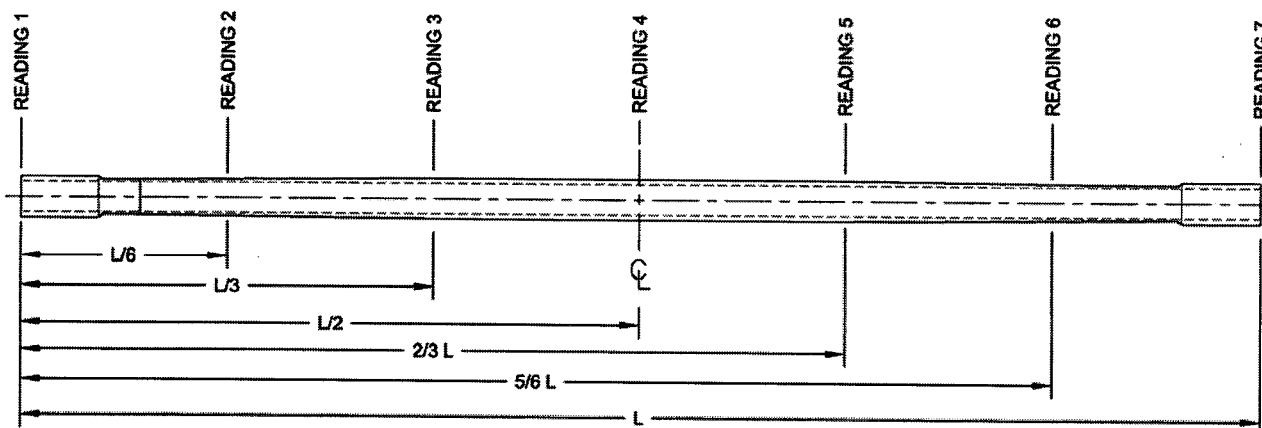
Machining ☐	Small Fab ☐	Prod. Eng. Coord. ☐	Quality ☐																																																																				
Thermoforming ☐	Finishing ☐	Rec/Store/Packaging ☐	Other ☐																																																																				
Large Fab ☐	Composite ☐	Supplier ☐																																																																					
Date: 15/10/26		Step #: 100		QTY Effective: 1		MRB (QSI042) Approval DAS 12 9-89 15/10/26																																																																	
Description Work Order Deviation				Disposition																																																																			
Well thickness measurement is over tolerance. $\begin{array}{r} \text{Min well} = 0.154 \\ \text{Dwg} = 0.164 \\ \hline \Delta = -0.010 \end{array}$				Min well is within allowable of raw mat'l.				Completed By DAS 12 9-89 15/10/26 Lead hand / Supervisor DAS 47 9-89 15-10-28 QC / QA Coordinator DAS 38 9-89 OCT 28 2015

Past Expiry Date ☐	Manufacturing Process ☐																																																																						
Misidentified ☐	Past Due ☐																																																																						
Pressure/Forced ☐	Temperature/Cure ☐	Power Loss/Surge ☐	Positioned Wrong ☐																																																																				
Bending ☐	Set-up ☐	Folio/Program ☐	Outside Dimensions ☐																																																																				
Centre Not Concentric ☒	BOM/Route ☐	Grain ☐	Over/Under tolerance ☒																																																																				
Cracks ☐	Broken/Damage/Defect ☐	Weld ☐	Part Incorrect ☐																																																																				
Crimp/Kink/Ripple/Wave ☐	Inspection Incomplete/Unqualified ☐	Wrong Stock Pulled ☐	Part Lost/Missing ☐																																																																				
Cuffs ☐	Contamination ☐	Out of Sequence ☐	Part Moved ☐

Location	WALL THICKNESS MEASUREMENT (IN)				Deviation Δw (max-min)	TOLERANCE
	w1	w2	w3	w4		
READING 1 L= 0"	.256	.262	.257	.249	.013	0.035"
READING 2 L= 17	.170	.183	.181	.167	.016	
READING 3 L= 33	.251	.254	.249	.241	.013	
READING 4 L= 50	.257	.259	.252	.252	.007	
READING 5 L= 67	.261	.256	.240	.241	.021	
READING 6 L= 83	.193	.186	.154	.167	<.039>	
READING 7 L= 99	.266	.264	.246	.246	.020

Work Order: <u>138628</u> Part No. <u>1226-667197 TRN</u> NCR No. <u>15-5411</u>		DISPOSITION Rework ☐ Scrap ☐ Use-as-is ☒ Suspected Unapproved ☐		AGAINST DEPARTMENT/PROCESS <table style="width:100%;"> <tr> <td>Skid-tube ☐</td> <td>Cross tube ☒</td> <td>Water Jet ☐</td> <td>Engineering ☐</td> </tr> <tr> <td>Machining ☐</td> <td>Small Fab ☐</td> <td>Prod. Eng. Coord. ☐</td> <td>Quality ☐</td> </tr> <tr> <td>Thermoforming ☐</td> <td>Finishing ☐</td> <td>Rec/Store/Packaging ☐</td> <td>Other ☐</td> </tr> <tr> <td>Large Fab ☐</td> <td>Composite ☐</td> <td>Supplier ☐</td> <td></td> </tr> </table>				Skid-tube ☐	Cross tube ☒	Water Jet ☐	Engineering ☐	Machining ☐	Small Fab ☐	Prod. Eng. Coord. ☐	Quality ☐	Thermoforming ☐	Finishing ☐	Rec/Store/Packaging ☐	Other ☐	Large Fab ☐	Composite ☐	Supplier ☐																																																	
Skid-tube ☐	Cross tube ☒	Water Jet ☐	Engineering ☐
